Manhole Inspection Summary

Manhole # S39QQ_008MH

Insp Date: **4/4/07 9:25 AM**

Location Address: **776 KIRK AVE**

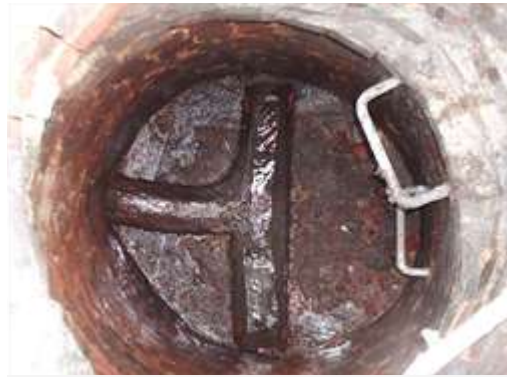
Top View

Evidence of surcharge - Bench debris.

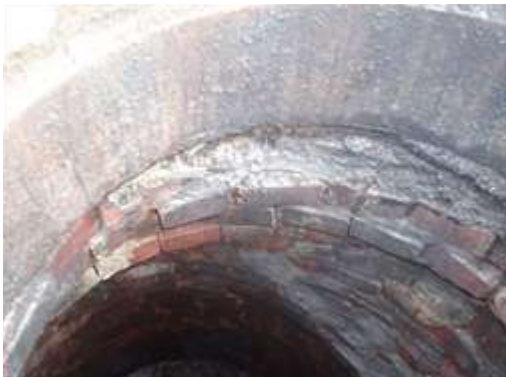
Defect

Frame leaks. Frame offset. Adjustment deterioration and infiltration.

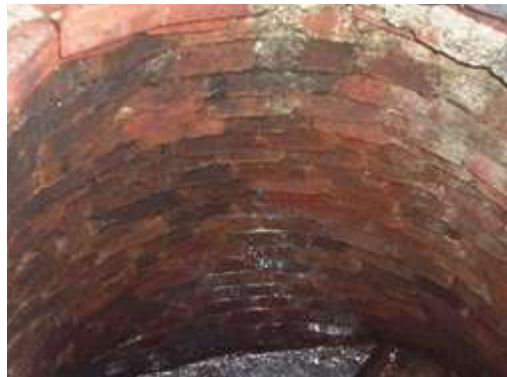
Defect

Adjustment, Corbel and Barrel infiltration.
